Crown® Flushometer

Crown® II (Obsolete)

PARTS LIST

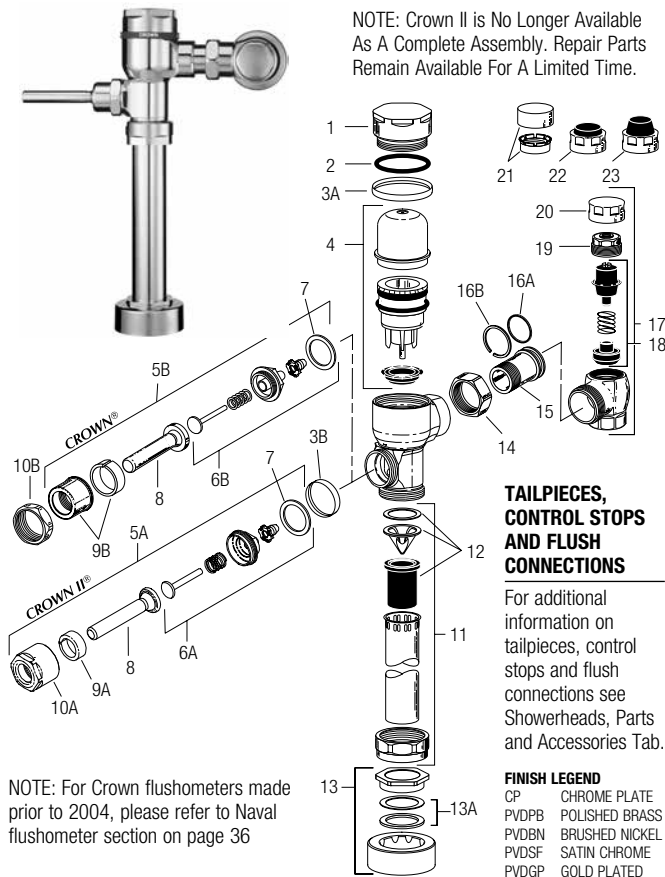
Item No.	Code No.	Part No.	Description
1.	0332006	CR-116	CP Cover
2.	0332030	CR-133	Cover O-ring
3.	0332045	CR-132-A	CP Handle and Cover Trim Ring Kit (Includes items 3A & 3B) (CROWN® II ONLY)
	0332046	CR-132-A	PVDPB Handle and Cover Trim Ring Kit (Includes items 3A & 3B) (CROWN® II ONLY)
	0332048	CR-132-A	PVDBN Handle and Cover Trim Ring Kit (Includes items 3A & 3B) (CROWN® II ONLY)
	0332049	CR-132-A	PVDSF Handle and Cover Trim Ring Kit (Includes items 3A & 3B) (CROWN® II ONLY)
3A.	0332035	CR-134	Cover Trim Ring (CROWN® ONLY)
	0332009	CR-120	PVDPB Cover Trim Ring (CROWN® II ONLY)
	0332032	CR-120	PVDGP Cover Trim Ring (CROWN® II ONLY)
	0332033	CR-120	PVDBN Cover Trim Ring (CROWN® II ONLY)
	0332034	CR-120	PVDSF Cover Trim Ring (CROWN® II ONLY)
3B.	0332005	CR-113	PVDPB Handle Trim Ring (CROWN® II ONLY)
	0332028	CR-113	PVDBN Handle Trim Ring (CROWN® II ONLY)
	0332029	CR-113	PVDSF Handle Trim Ring (CROWN® II ONLY)

4.	3332003	CR-1004-A	Piston Kit – 1.6 gpf (6.0 Lpf) Water Closet
	3332013	CR-1011-A	Piston Kit – 1.28 gpf (4.8 Lpf) Water Closet
	3332004	CR-1005-A	Piston Kit – 1.0 gpf (3.8 Lpf) Urinal
	3332005	CR-1006-A	Piston Kit – 0.5 gpf (1.9 Lpf) Urinal
	3332017	CR-1015-A	Piston Kit – 0.25 gpf (1.0 Lpf) Urinal
	3332016	CR-1014-A	Piston Kit – 0.125 gpf (0.5 Lpf) Urinal

ALL PISTON KITS INCLUDE MAIN SEAT (see item 4 table to right) AND CR-124-A INSIDE COVER ASSEMBLY AS SHOWN IN ITEM 4. PISTON KIT COMPONENTS TABLE TO THE RIGHT.

ITEM 4. PISTON KIT COMPONENTS

Item	Code No.	Part No.	Description
A.	***	CR-124-A	Inside Cover Sub-Assembly
B.	***	***	Piston Cover
C.	5332095	CR-68-A	Molded Cup – 12/pkg
D.	5328019	SH-406	Spring – 12/pkg
E.	***	***	Relief Valve
F.	0307116	G-95	Relief Valve Seat
G.	***	***	Piston Body
H.	***	CR-125-A	Main Seat – 6/pkg (1.0 gpf)
	***	CR-170-A	Main Seat – 6/pkg (0.125 gpf, 0.25 gpf and 0.5 gpf)
I.	0307210	G-85	Filter O-ring
J.	0332124	CR-169	O-ring (for use with CR-125-A main seat ONLY)*
	5308958	H-589	O-ring* 6/pkg
