BOTTLED WATER COMPANY IMPLEMENTS LARGE-FORMAT IR WINDOWS

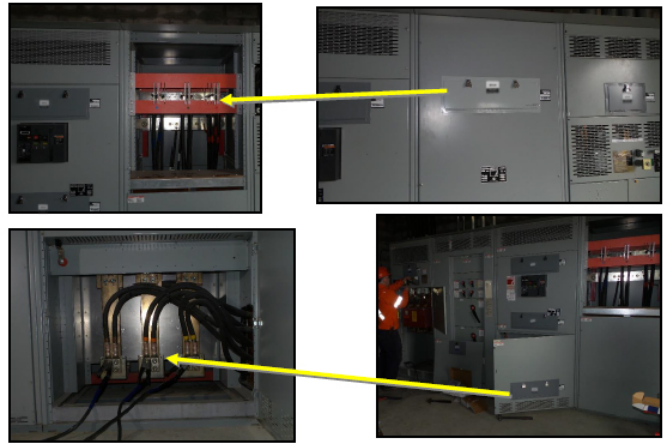
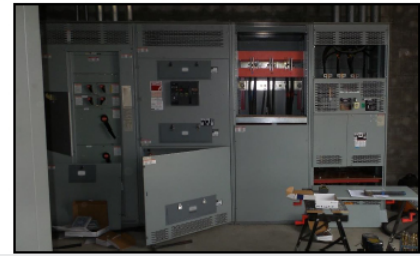
SWGR 96-SWG-01
Cabinet A, B, C

Installation Requirements:
Incoming line connections IRW-24PC
Main Breaker IRW-24PC

The bottling company installed 24-inch large-format IR windows in main breaker buss cabinets

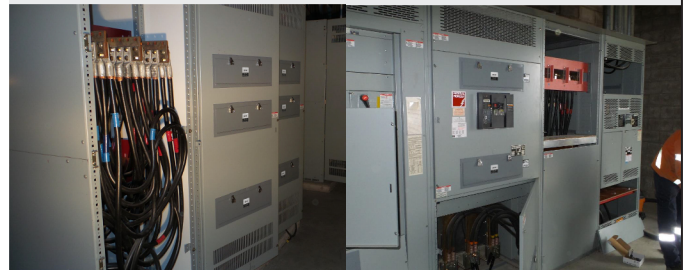
Incoming line connection and main breaker cabinets were also fitted with 24-inch windows
