Optima® Royal® ES-S TMO Exposed Flushometers

TROUBLESHOOTING GUIDE

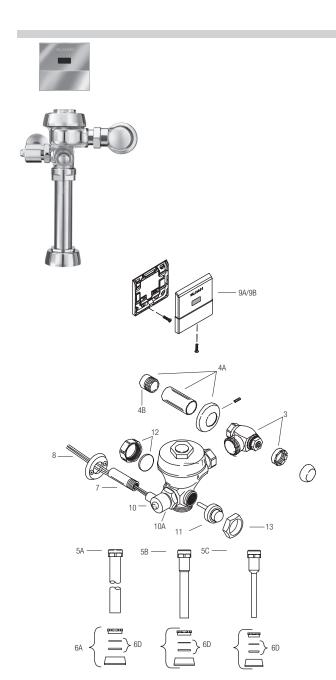
ROYAL® OPTIMA® ES-S TMO EXPOSED FLUSHOMETER PARTS LIST

Item No.	Code No.	Part No.	Description
		Part No.	Description
1.	‡	II 700 A	Solenoid Activated Valve Assembly
2.	2200770	H-700-A	Bak-Chek® Control Stop
3.	3308772	H-1010-A	Vandal Resistant Stop Cap
4A.	3308782	H-633-AA	1" (25 mm) Sweat Solder Kit
4B.	3308603	H-532	Adapter, 1" NPT to 1" Tube
	3308607	H-535.	Adapter, 3/4" NPT to 3/4" Tube
5A.	_	V-600-AA	1-1/2" (38 mm) Vacuum Breaker Assembly CP (Models 110/111, 115, and 116)
5B.	_	V-600-AA	1-1/4" (32 mm) x 9" (229 mm) Vacuum Breaker Assembly CP (Model 180 ES-S)
5C.	_	V-600-AA	3/4" (19 mm) x 9" (229 mm) Vacuum Breaker Assembly CP (Model 186 ES-S)
6A.	0306146	F-5-AT	1-1/2" (38 mm) Spud Coupling Assembly CP (Models 110/111, 115, and 116)
6B.	0306140	F-5-AU	1-1/4" (32 mm) Spud Coupling Assembly CP (Model 180)
6C.	0306125	F-5-AW	3/4" (19 mm) Spud Coupling Assembly CP (Model 186)
6D.	SEE SLIP JO	INT GASKET	S AND RINGS ON TABLE BELOW

7.	‡	F-15	Tail Assembly
8.	0302323PK	B-110-A	Flange Assembly
9A.	3305107	EL-635-A	CP Cover Plate with Sensor (Mounting Plate and Screws included) (Models 110/111, 115, and 116)
9B.	3305101	EL-645-A	CP Cover Plate with Sensor (Mounting Plate and Screws included) (Models 180 and 186)

10.	0305329	EL-124-2	CP 24V Solenoid Assembly Only
10A	3305043	EL-128-A	Actuator Cartridge Assembly (not shown detailed)
	3305045	EL-1028-A	Solenoid Assembly w/ Cartridge Assembly

11.	0303009	C-2-A	True Mechanical Override Button
12.	3325814	EBV-1017-A	CP Valve Handle Cap
13.	0301082PK	A-6	CP Nut
_	3345080	EL-1026-A	ES-S to ES-S-TMO Conversion Kit Exposed includes Body/Tail assembly (no inside parts or covers) #11, #12, #13, D0-22 and EL-110 o-ring
	3305043	EL-128-A	Actuator Cartridge

14.	3302306	B-51-A	Triple Seal Handle Repair Kit
15.	3345080	EL-126-A	ESS to TMO Retrofit Conversion Kit (Exposed*)
	3388015	H-1015-A	Flow Control Kit (HEU Only) (not Shown)

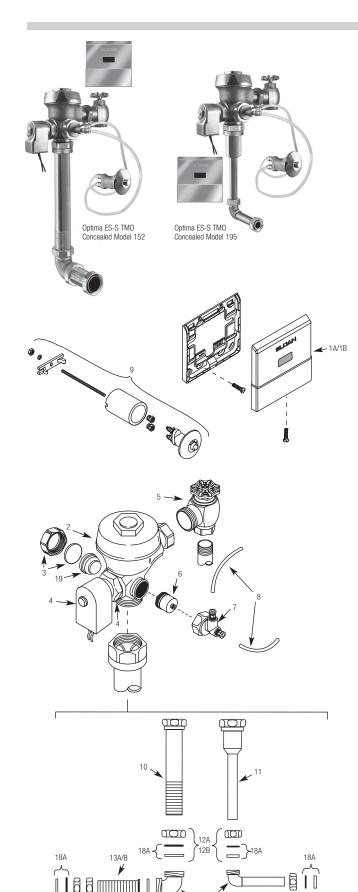
ROY!	AL® OPTIM	A® ES-S TMO	CONCEALED FLUSHOMETER PARTS LIST
Item		-	
No.	Code No.	Part No.	Description
1A.	3305107	EL-635-A	CP Cover Plate with Sensor (Mounting Screws included) (Model 152)
1B.	3305101	EL-645-A	CP Cover Plate with Sensor (Mounting Screws included) (Model 195)

2.	‡	_	Valve Assembly
3.	3301093	A-1013-A	Concealed Valve Handle Cap RB
4.	0305331	EL-138-2	RB Concealed 24V Solenoid Assembly
4A	. 3305043	EL-128-A	Actuator Cartridge Assembly Only

5.	‡	H-730-A	RB Bak-Chek® Control Stop
6.	3318001	HY-83-A	Actuator Cartridge
7.	3318005	HY-109-A-1	Valve Actuator Assembly
8.	0318093	HY-30	1/4" (6 mm) x 48" (1219 mm) Connecting Tubes

9.	0318117	HY-100-A-1	Metal Push Button Assembly
10.	‡	V-500-AA	1-1/2" (38 mm) Vacuum Breaker Assembly RB (Model 152)
11.	‡	V-500-AA	3/4" (19 mm) Vacuum Breaker Assembly RB (Model 192)
12A.	0306088	F-2-AT	1-1/2" (38 mm) Slip Joint Coupling Assembly RB (Model 152)
12B.	0306054	F-2-AW	3/4" (19 mm) Slip Joint Coupling Assembly RB (Model 192)
13A.	‡	F-110	1-1/4" (32 mm) Outlet Tube with Flange and Scoring (Model 152)
13B.	‡	F-100	1-1/2" (38 mm) Outlet Tube with Flange and Scoring (Model 152)
14A.	0306059	F-2-AU	1-1/4" (32 mm) Slip Joint Coupling Assembly RB (Model 152)
14B.	0306088	F-2-AT	1-1/2" (38 mm) Slip Joint Coupling Assembly RB (Model 152)

15.	0306091	F-2-A	1-1/2" (38 mm) Coupling with S-21 Gasket (Model 152)
16.	0206146P	K F-21	1-1/2" (38 mm) Double Male Slip Joint Elbow
17.	‡	F-15-A	ELL with 3/4" (19 mm) Tail

18.	0306054	F-2-AW	3/4" (19 mm) Slip Joint Coupling
18A.	SEE SLIP	JOINT GASKET	S AND RINGS TABLE BELOW
19.	0305190	EL-190-A	Handle Adapter Assembly
20.	3345020	EL-1033-A	ESS to TMO Retrofit Kit (Concealed)*
	3388015	H-1015-A	Flow Control Kit (HEU Only) (not Shown)

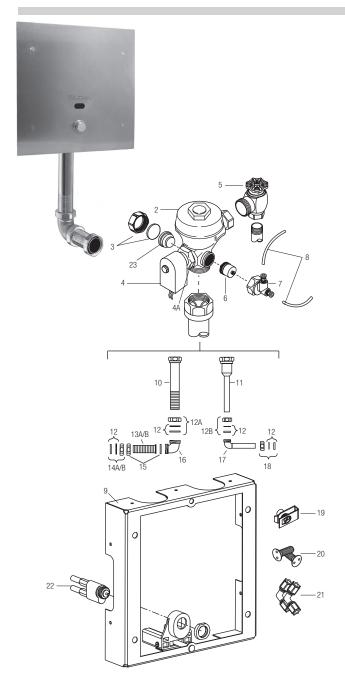
Item	Ondo No	Dowl No.	Description
No.	Code No.	Part No. WB-55-A	Description Wall Box Cover Plate Assembly (Model 152)
1A.	_	WB-55-A WB-60-A	Wall Box Cover Plate Assembly (Model 195)
1B.	_	WD-0U-A	, , , , , , , , , , , , , , , , , , ,

2. 3.	‡ 3301093	Λ 1012 Λ	Valve Assembly
		A-1013-A	Concealed Valve Handle Cap RB
4.	0305331	EL-138-2 EL-128-A	RB Concealed 24V Solenoid Assembly
			Actuator Cartridge Assembly Only

5.	2010001	H-730-A	RB Bak-Chek® Control Stop
6.	3318001	HY-83-A	Actuator Cartridge
7.	3318005	HY-109-A-1	Valve Actuator Assembly
8.	0318117	HY-30	1/4" (6 mm) x 48" (1219 mm) Connecting Tubes

10.	‡	V-500-AA	1-1/2" (38 mm) Vacuum Breaker Assembly RB (Model 152)
11.	‡	V-500-AA	3/4" (19 mm) Vacuum Breaker Assembly RB (Model 192)
12.	SEE SLIP JO	DINT GASKET	S AND RINGS TABLE BELOW
2A.	0306088	F-2-AT	1-1/2" (38 mm) Slip Joint Coupling Assembly RB (Model 152)
12B.	0306054	F-2-AW	3/4" (19 mm) Slip Joint Coupling Assembly RB (Model 192)
3A.	‡	F-110	1-1/4" (32 mm) Outlet Tube Flanged and Scored (Model 152)
13B.	‡	F-100	1-1/2" (38 mm) Outlet Tube Flanged and Scored (Model 152)
14A.	0306059	F-2-AU	1-1/4" (32 mm) Slip Joint Coupling Assembly RB (Model 152)
14B.	0306088	F-2-AT	1-1/2" (38 mm) Slip Joint Coupling Assembly RB (Model 152)

15.	0306091	F-2-A	1-1/2" (38 mm) Coupling with S-21 Gasket (Model 152) [†]
16.	0206146PK	F-21	1-1/2" (38 mm) Double Male Slip Joint Elbow
17.	0306366	F-15-A	ELL with 3/4" (19 mm) Tail (Model 195)†

18.	0306054	F-2-AW	3/4" (19 mm) Slip Joint Coupling
19.	0334017	WB-18	U-Type Nuts (4) 1/4-20
20.	_	WB-49	Tamper Resistant Screws (4) 1/4-20 x 1-1/2
21.		HY-126	Elbow Fitting (2)

22.	0318123	HY-71-A	Hydraulic Actuator Assembly
23.	0305190	EL-190-A	Handle Adapter Assembly
